INDUSTRIAL EYE

Qualification of ultrasonic testing of Cat® ridged dump trucks ball studs from the inferior position of the stud

Ball studs connect the steering linkages in Cat® Ridged Dump Trucks and are a critical component in these trucks.

AUTHOR: NEIL YOUNG
GENERAL MANAGER, ASSET RELIABILITY INSPECTIONS

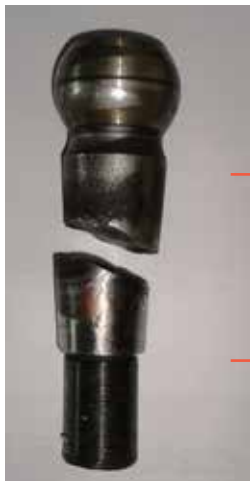
The Cat® dump truck service manuals state that ball studs should be tested ultrasonically every 1000 hours (approximately testing them every 3 months if the trucks work day and night shift) for in-service cracking to prevent loss of steering in the event of one cracking through (Figure 3)² Loss of steering is obviously a major safety concern for these giant vehicles^{3,4} and (haul) road side repairs are more difficult and labour intensive when compared to planned maintenance performed in the workshop. Government Safety Bulletins have been released in Australia regarding cracking of ball studs and detailing steering failures^{3,4}.

Fig. 3: Failed Ball Stud

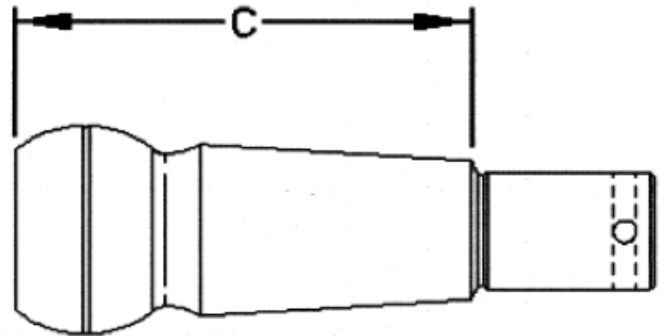
Fig. 5: Area of Interest (Cracking) Shown as "C" as per Manufacturer Inspection Procedure

area of interest (where the stud typically cracks) from the manufacturer inspection procedure² and the cotter pin locations (Figure 5 and 6).

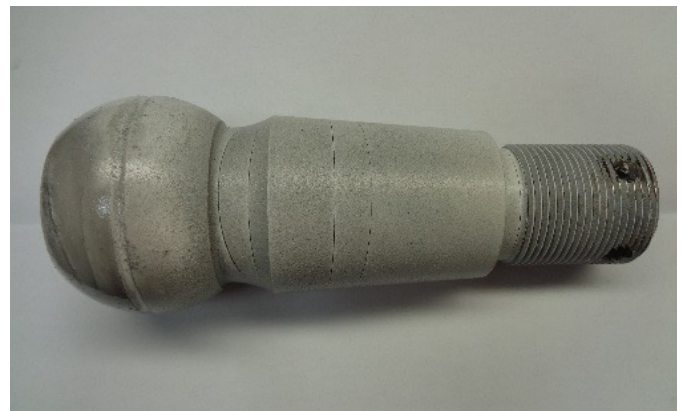
- The taper of the stud and attempting to get sound from a smaller diameter to the larger diameter where the studs crack and
- The loss of cross sectional area within the threaded section due to cotter pin holes in this area.

Fig. 6: Cotter Pin Holes (2 off) on a Cracked Cat 777 Ball Stud.

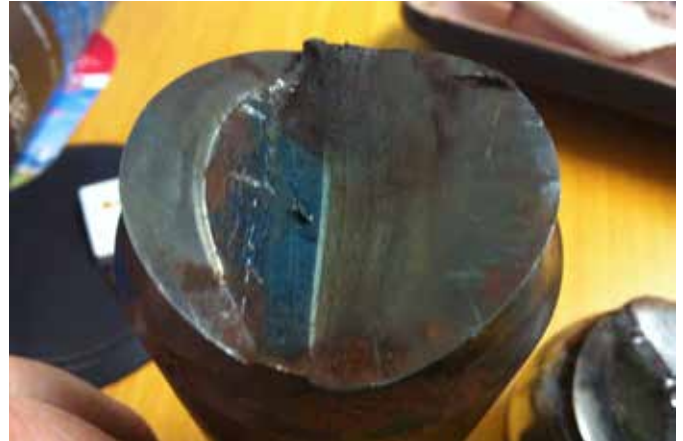
Fig. 8: Failed Ball Stud Showing Fatigue Beach Marks (up to ~70% cross sectional area) Before Brittle Fracture.

The cracking mode is from an in-service fatigue mode⁹ which means the studs crack from the outside surface in making them suitable for magnetic particle testing. The studs were all “gold standard” tested with magnetic particle testing to confirm the presence of cracking (Figure 8) using a surface test method following ultrasonic testing.

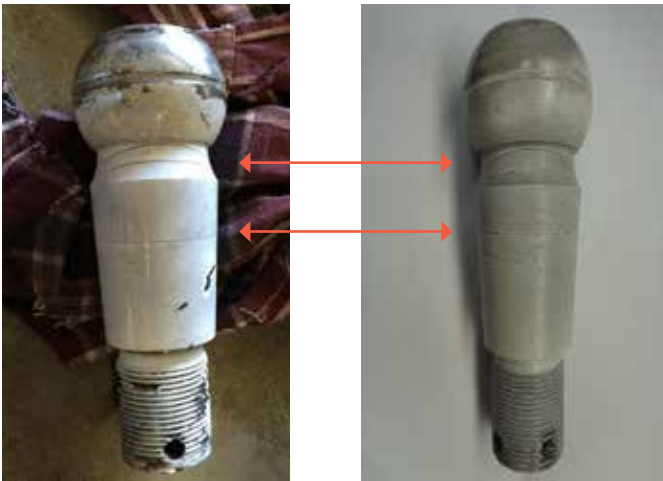
Fig. 9: Typical Cracked Studs (black circumferential lines are cracking)

5 of the 10 studs were confirmed to be cracked using magnetic particle testing. No false positives were detected ultrasonically. Typical cracking evident is shown below in Figure 9.

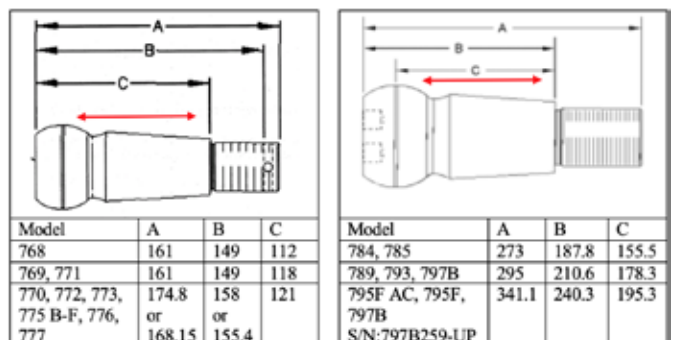
Areas of concern that are susceptible to cracking are highlighted below (Figure 12) in red and indications in these areas were assessed as acceptable or not as per the acceptance criteria detailed below.

Results were recorded and assessed against the following criterion. Ultrasonic indications greater than 20% full screen height (FSH) when at evaluation sensitivity as detailed in ARI's test procedure, in the area identified as susceptible to cracking shall be rejected.

Fig. 12: Area of ball stud susceptible to cracking highlighted in red.
