INDUSTRIAL EYE

Qualification of ultrasonic testing of Cat® ridged dump trucks ball studs from the inferior position of the stud

Ball studs connect the steering linkages in Cat® Ridged Dump Trucks and are a critical component in these trucks.

AUTHOR: NEIL YOUNG
GENERAL MANAGER, ASSET RELIABILITY INSPECTIONS

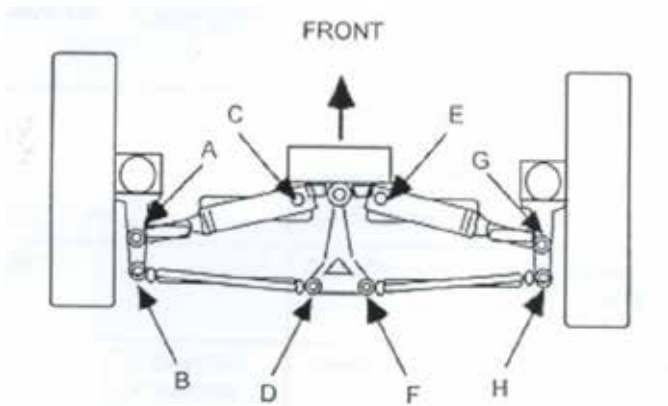
Fig. 2: Cat® Ridged Dump Truck Ball Stud Locations (shown by arrows/letters)

Ball studs connect the steering linkages together in Cat® Ridged Dump Trucks (Figure 1.) and are prone to cracking¹. Manufacturing guidelines prescribe regular testing ultrasonically to assess the integrity of ball studs¹. There are eight off ball studs per truck (Figure 2) and they come in different sizes depending on the truck size¹.

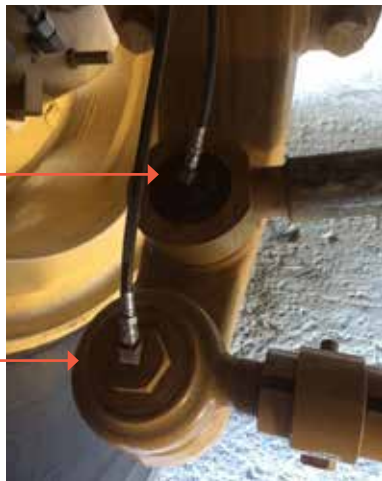
Fig. 4: Access Point to the Top of the Ball Stud (position A & B from Figure 2.)

The Cat® testing procedure specifies removing the grease caps above the ball studs and testing the stud from the top position) which is the non-threaded end². To test from the top position a technician is required to remove the grease caps, perform the test and replace the grease caps which on average takes two technicians 0.75-1.5 hours per truck (time specified is the average time taken to test trucks over the last 3 years)⁵ See Figure 4 to illustrate top view of ball stud. The testing of the ball studs only takes ~0.25 hours per truck and therefore the majority of the time the truck is out of service is due to obtaining access to the test area.

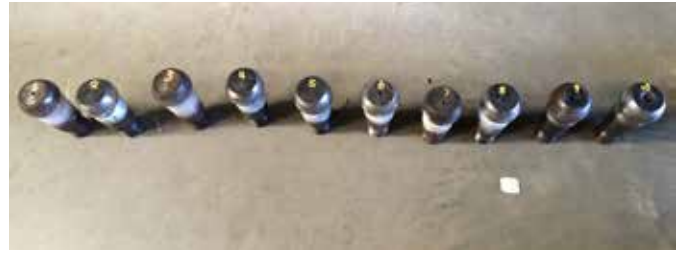
Fig. 7: Ball Studs for Blind Testing.

ARI have collected numerous studs over the years for training and reference. Not all studs collected are cracked as some have been removed by asset owners for wear during servicing and in some cases studs were not cracked but worn/damaged and when tested ultrasonically in situ were mistakenly called as cracked studs and removed. Ten studs were available for testing, n=10 (Figure 7).
